## STRUCTURAL CONDITION ASSESSMENT REPORT

**St. Patrick Catholic Church**

725 4<sup>th</sup> Street

American Structurepoint Project No. 2018.01713

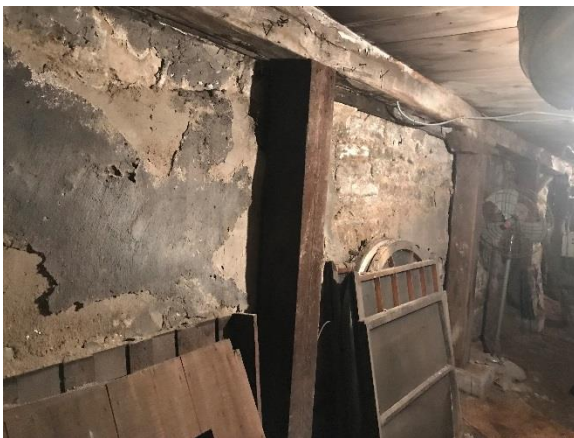
Photo BD8

The main level was supported by rough sawn wood planks or joists bearing on timber beams and posts (Photos BD7 and BD8). Supplemental wood beams and posts were located along the south foundation wall (Photo BD9). Roof framing consisted rough sawn rafters supported by purlins spanning between reinforced heavy timber trusses (Photo BD10).

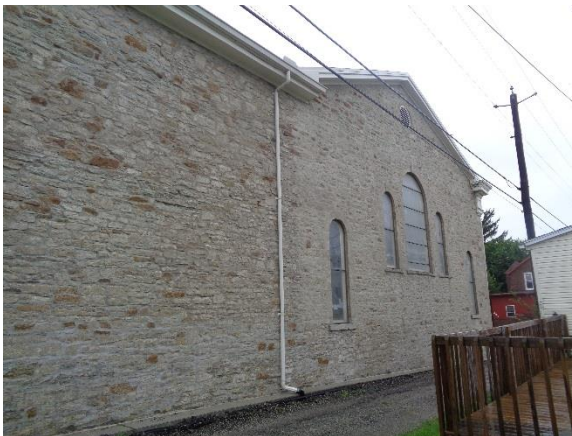
Photo D1

1. Limestone window sills throughout the structure were typically weathered (Photos D9 and D10). Cracks exhibiting no sealant or failed sealant were observed at select sills (Photos D10 through D12).
2. At select windows, the mortar joint between jamb and sill pieces was eroded (Photo D10).
3. At select windows, staining was observed at the masonry course directly below the sill (Photo D4).
4. Above the southernmost basement window well on the east elevation, an open mortar joint was observed (Photo D13).
5. On the north elevation, a concrete curb was located at the joint between the asphalt and the north elevation limestone. Joint sealant between the concrete and the limestone wall was applied on top of existing sealant, and was partially failed, characteristic of sealant which was improperly applied and has reached the end of its reduced lifespan (Photos D1, D14 and 15).

The exterior limestone masonry was weathered and eroded, but in fair-to-good condition overall given the age of the building. Due to the age, however, we recommend regular maintenance of the exterior masonry by a qualified masonry contractor with experience pointing and repairing historical limestone structures. The masonry should be reviewed, with repointing and other deleterious conditions remediated, at least every five to seven years.

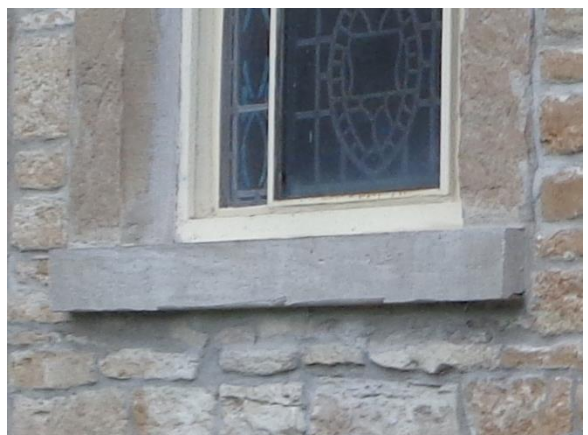
Photo D8

Evidence of recent repairs such as repointing, replaced cast stone pieces with the water table belt course, and concrete window sills were observed throughout various regions of each elevation (Photos D6 through D8).

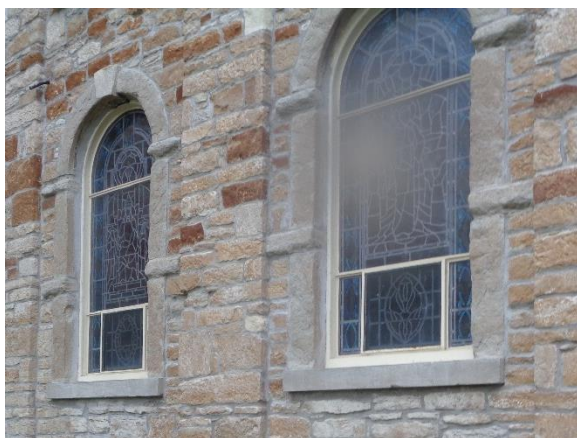
Photo E3

Stained glass windows were located along each elevation, some of which protected by acrylic storm panels on the exterior (Photo E3).

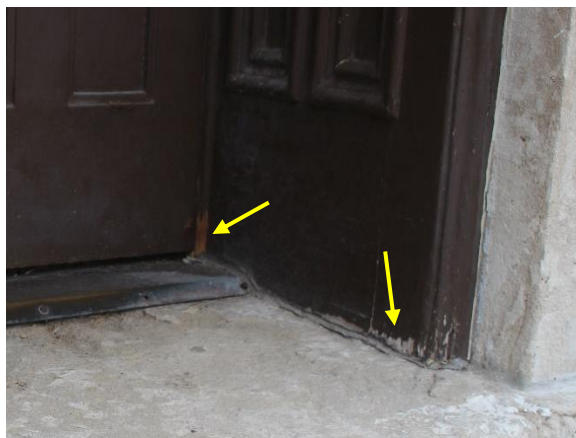
Photo E4

1. Typical at the wood doors, jambs exhibited missing paint and exposed wood trim along the bottom edges (Photo E4).
2. Window and window storm panel sealant was in fair overall condition with sealant beginning to fail at only select storm panels throughout the building (Photo E5).
3. At a second level window at the east addition, sealant was not present (Photo E6).

The doors and windows were in fair overall condition. Within the next five years, we recommend repainting the wood doors and door jambs as well as re-sealing the windows and window storms. At the second level window exhibiting no sealant, we recommend applying sealant within the next year.

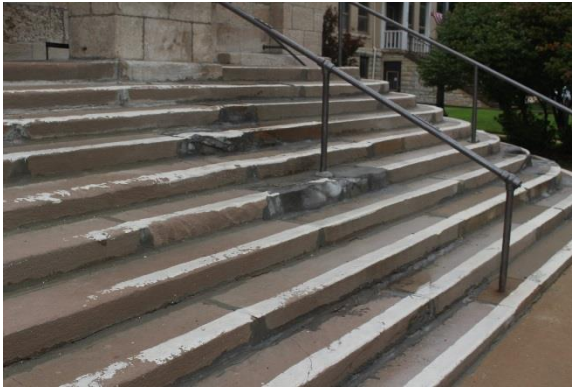
Photo F1

The stairs and landing at the south entrance consisted of concrete treads and risers and exhibited patch repairs throughout (Photos F1 and F2).

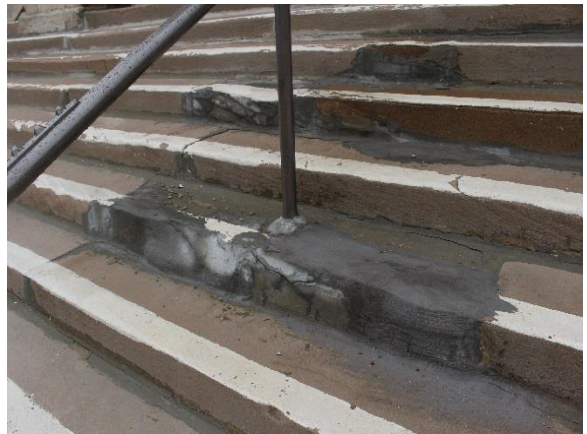
Photo F6

- b. Treads exhibited spalled concrete and open joints (Photos F6 and F7).
2. At the west elevation, a downspout had separated just below the cornice (Photo F8).

The stairs are in overall poor condition and the delaminations observed represent a potential future safety hazard. Within the next five years, we recommend replacing the concrete stairs.

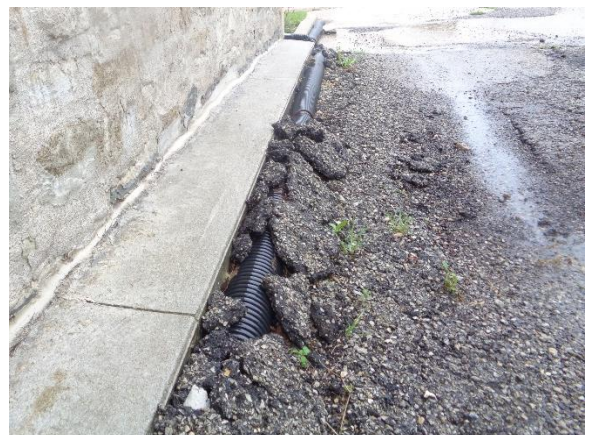
Photo F12

5. At the north elevation, downspouts drained into a partially buried corrugated plastic pipe which was routed along a concrete curb in the alley (Photos F11 and F12). Based on conversations with church officials, we understand that curb and corrugated piping were installed in an attempt to mitigate water infiltration into the north masonry wall and alleviate damages to the interior wall finishes. The adjacent alley drive was comprised of asphalt in poor condition, and exhibited a slight pitch toward the church.

At the north elevation, we recommend installing a waterproofing and drainage system on the exterior face of the wall. Refer to Section J for further discussion.
