## STRUCTURAL CONDITION ASSESSMENT REPORT

### **St. Hyacinth Catholic Church**

American Structurepoint Project No. 2018.01714

February 13, 2019

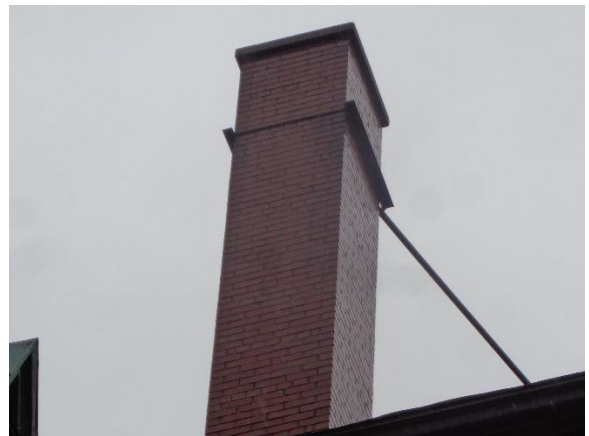
Photo BD12

Notable roof appurtenances included a formed copper steeple above the altar and a brick chimney (Photos BD11 and BD12).

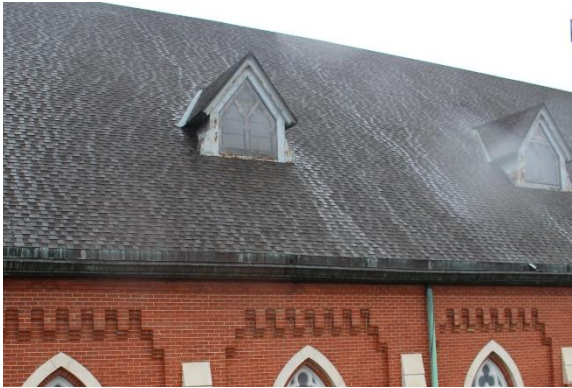
Photo B1

The gabled roof over the main congregation area consisted of laminated fiberglass asphalt composition shingles in fair-to-poor condition (Photo B1). Flat roof areas over the northeast and northwest sacristies were comprised of copper sheet roofing in good overall condition (Photo B2). Three skylight dormers were located on the east and west elevations and were clad with light-gauge metal sheeting; the valleys between the dormers and main roof consisted of copper valley metal (Photo B3). Recent shingle repairs (circa 2017) were observed on the east-facing slope over the choir loft (Photo B4); recent sealant repairs were observed along copper wall flashing (Photo B5).

The congregation area shingles are at the end of their useful life, therefore, we recommend replacing the shingles within the next two years. Due to the suspected age of the roof sheathing, partial to complete replacement of the roof sheathing may be necessary. At the time of the roofing replacement, we recommend repairing any openings in the copper trim. We also recommend closely inspecting the copper ventilation steeple for breaches or leaks and repairing or sealing as necessary.

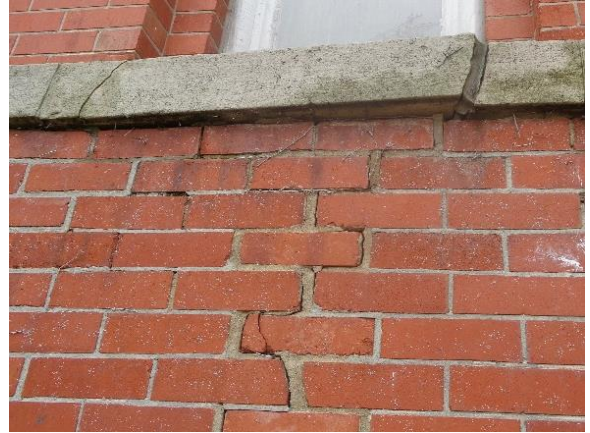
Photo C8

1. At both steeples, cracking was observed through cast stone sills below upper, middle, and lower level steeple windows, and through the brick and mortar joints beneath the subject windows (Photos C6 through C8).

At both steeples, we recommend repointing brick at the lower, middle, and upper levels, as well as repointing cast stone (sills, arches, etc.) throughout all steeple levels, within the next two years. At the same time, we recommend addressing the lower level separation observed at the southeast corner of the east steeple by pointing the joint and installing helical brick ties so as to prevent further water infiltration.

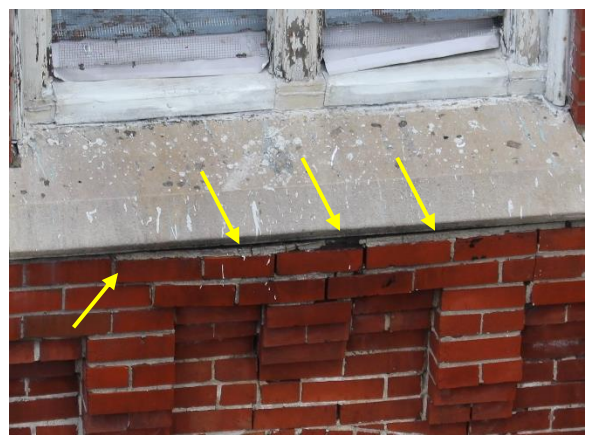
Photo C12

- b. At cast stone banding at each steeple level, joints typically exhibited fractured, loose, or missing mortar (Photo C11).
  - c. At the clock chamber, open mortar joints and dislodge brick were observed within the brickwork above and below the clock faces (Photos C12 and C13).

At the west steeple, we recommend repointing the entire clock chamber within the next two years. The missing cast stone piece represents an active path of water infiltration and should be addressed as soon as possible.

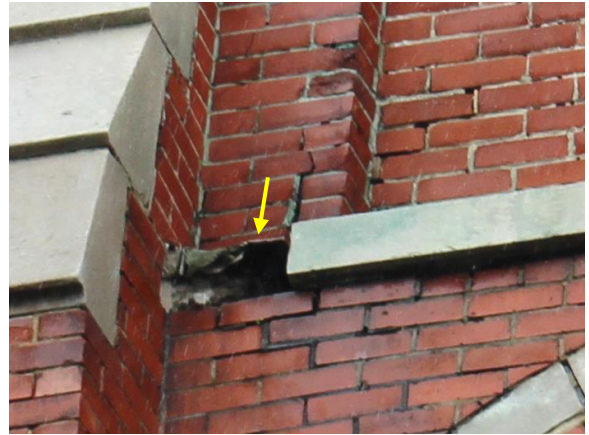
Photo C14

- d. Select cast stone elements within the corner pilasters exhibited delaminations characteristic of freeze-thaw damage (Photo C13 and C15). At the northeast corner of the north steeple elevation, a cast stone piece was missing beneath the clock chamber (Photo C14). Lift access prevented further inspection of this area from above.

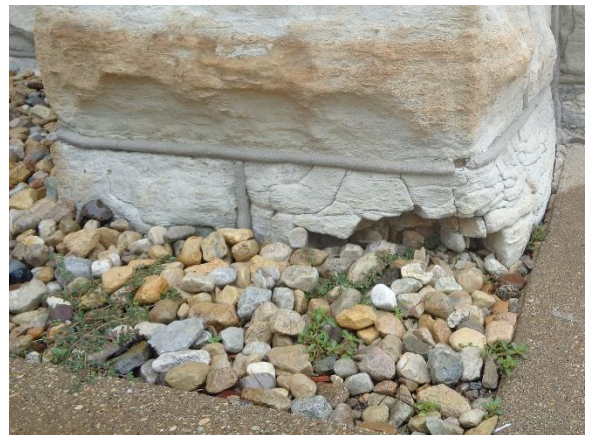
Photo C16

- e. The bottom course of limestone masonry exhibited craze cracking and was severely eroded (Photo C16).

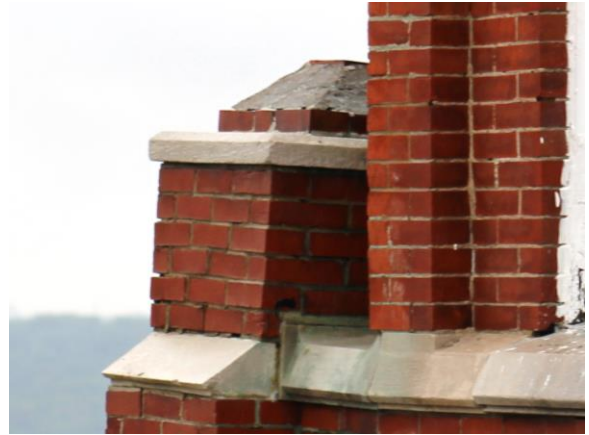
Photo C20

- b. The belfry pinnacles were noticeably leaning toward the center of the steeple; open mortar joints and fractured brick were observed throughout the masonry at and below the pinnacles (Photos C20 and C21).

At the east steeple, the belfry and clock chamber exhibited open mortar joints, separations at prior sealant repairs, and fractured and dislodged brick and were in very poor condition. We recommend temporarily removing portions of or the entire east steeple spire and rebuilding the east steeple belfry and clock chamber similar to the rebuild previously performed at the west steeple belfry.

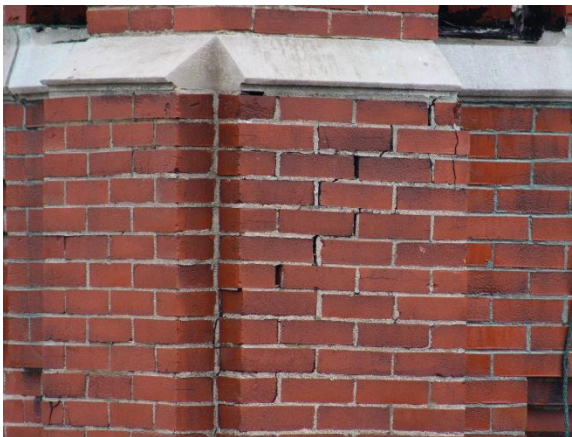
Photo C21

- d. Masonry at the belfry and clock chamber exhibited severe deterioration including open mortar joints, separations at prior sealant repairs, and fractured and dislodged brick (Photos C21, and C23 through C25).

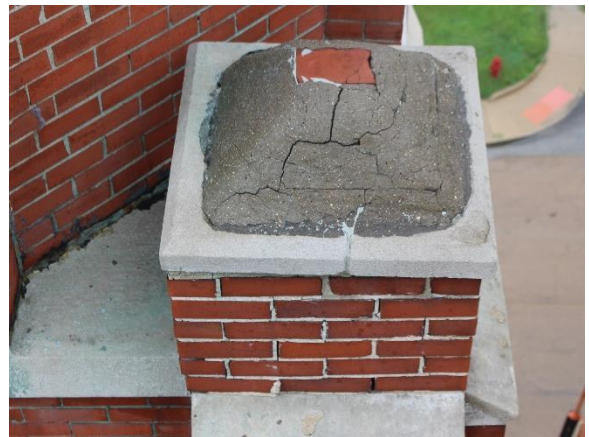
Photo C22

- c. At the southeast belfry pinnacle, the capstone was missing. The exposed cementitious repair in place of the capstone was fractured and spalling (Photo C4 and C22).

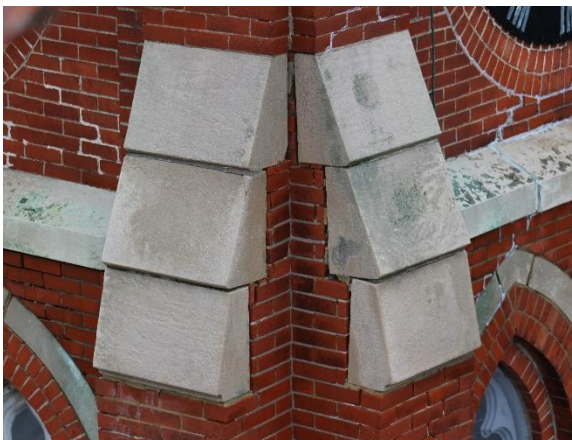
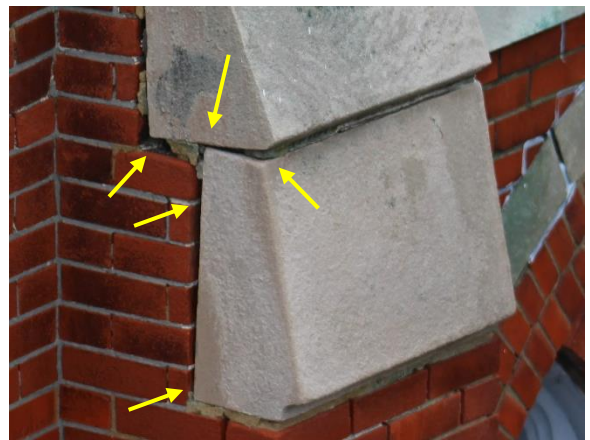
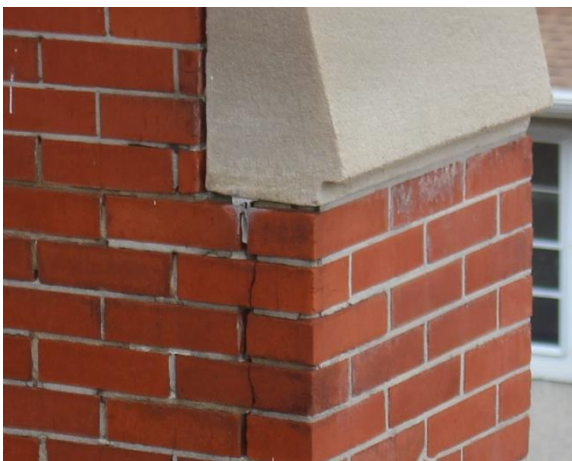
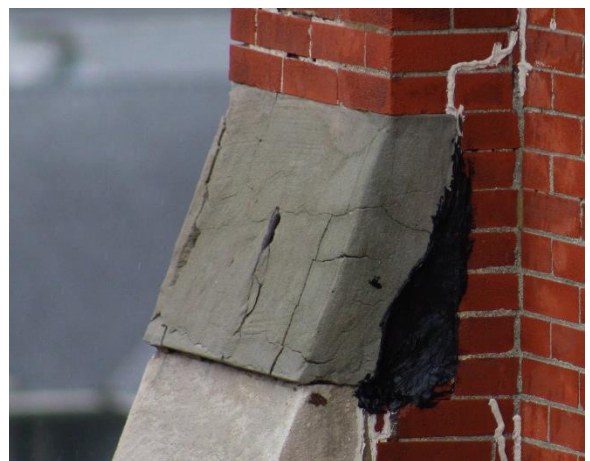
- e. At the middle and upper levels, open mortar joints were common throughout the elevations (Photos C25 and D26).
  - f. At the corner pilasters, cast stone transition pieces exhibited open mortar joints on all sides. Closer inspection revealed many of the stones were dislodged; at some pilasters, fractured brickwork was located immediately beneath the lowest cast stone element. At the southeast steeple corner, a cementitious patch exhibited cracking and scaling consistent with freeze-thaw damage (Photos C27 through C30).

At the cast stone pilaster transitions on both steeples, we recommend repointing the mortar joints surrounding the cast stone pieces, and rebuilding any fractured underlying brick within the next year. Each of the cast stone pilaster transition pieces exhibit one or more of the following: open mortar joints, displacement from their original position, or are supported by cracked brickwork; the sum total of which represents a *safety hazard*.

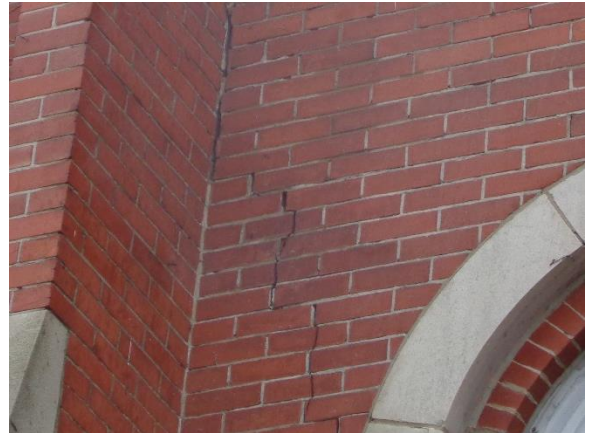
Photo C32

- g. At the lower level interior corner located between the east steeple wall and southeast pilaster, a separation approximately  $\frac{3}{4}$ " wide was observed below the cast stone sill and transitioning to a step crack propagating to the nearest east elevation window (Photos C31 and C32). The cast stone sill above the wall separation was also cracked (Photo C31).

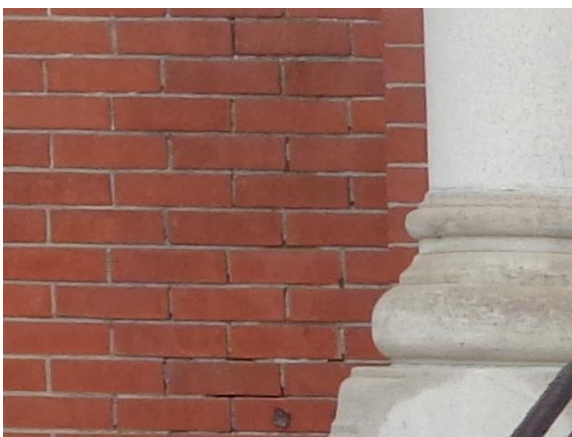
Photo D5

1. On the south elevation, open mortar joints were observed below a downspout which discharged approximately 10 feet above grade (Photo D5).
2. Select areas of open mortar joints were observed below some windows and at some pilasters (Photos D6 and D7).

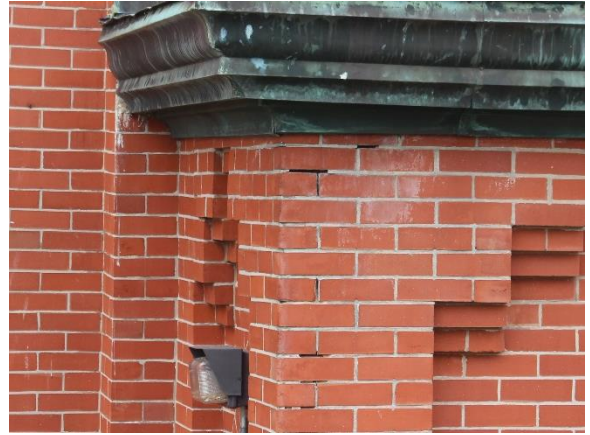
Photo D8

3. Throughout the building, select areas of open mortar joints were observed below the copper gutters (Photo D8).
4. At the west elevation, a small piece of cast stone was fractured, and suspended above the side entrance stoop (Photo D9).

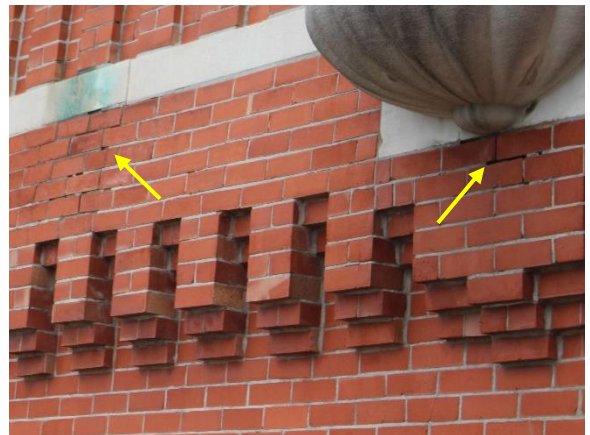
Photo D10

5. At the south elevation, open mortar joints were observed below the cast stone banding; separations were observed at prior cast stone joint repairs (Photos D10 and D11).

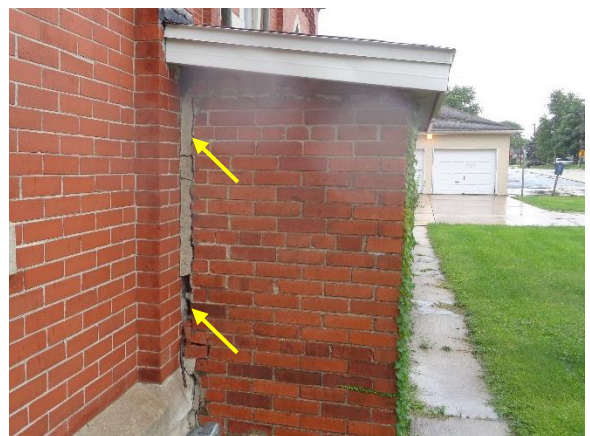
Photo D12

6. At the grade level limestone courses on the south and east elevations, failed sealant was observed at the cove joint along the sidewalk (Photo D4).
7. At the north elevation, a separation of approximately one inch was observed at the joint between the east wall of the basement entrance and the north sacristy wall (Photo D12).
