## STRUCTURAL CONDITION ASSESSMENT REPORT

**St. Patrick Catholic Church**

725 4<sup>th</sup> Street

American Structurepoint Project No. 2018.01713

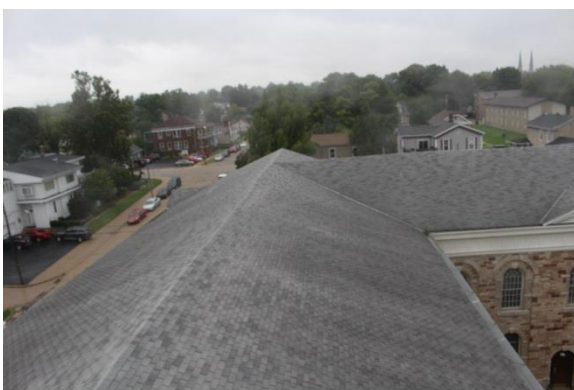
Photo BD11

The roof was comprised of three tab asphalt composition shingles with an aluminum clad steel framed steeple at the south elevation (Photos BD11 and BD12).

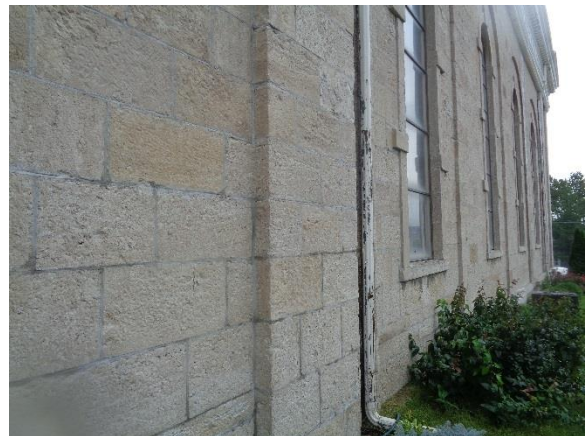
Photo D1

1. Limestone window sills throughout the structure were typically weathered (Photos D9 and D10). Cracks exhibiting no sealant or failed sealant were observed at select sills (Photos D10 through D12).
2. At select windows, the mortar joint between jamb and sill pieces was eroded (Photo D10).
3. At select windows, staining was observed at the masonry course directly below the sill (Photo D4).
4. Above the southernmost basement window well on the east elevation, an open mortar joint was observed (Photo D13).
5. On the north elevation, a concrete curb was located at the joint between the asphalt and the north elevation limestone. Joint sealant between the concrete and the limestone wall was applied on top of existing sealant, and was partially failed, characteristic of sealant which was improperly applied and has reached the end of its reduced lifespan (Photos D1, D14 and 15).

The exterior limestone masonry was weathered and eroded, but in fair-to-good condition overall given the age of the building. Due to the age, however, we recommend regular maintenance of the exterior masonry by a qualified masonry contractor with experience pointing and repairing historical limestone structures. The masonry should be reviewed, with repointing and other deleterious conditions remediated, at least every five to seven years.

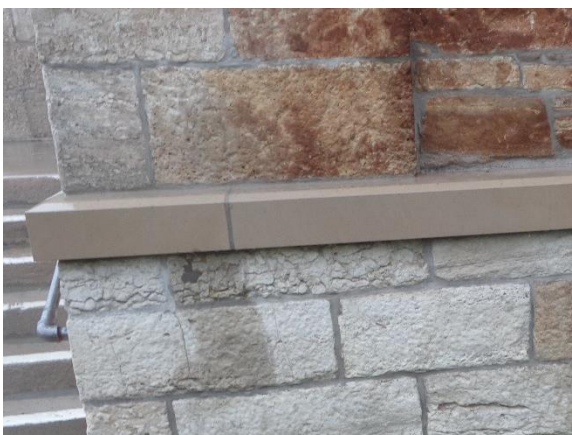
Photo D6

Evidence of recent repairs such as repointing, replaced cast stone pieces with the water table belt course, and concrete window sills were observed throughout various regions of each elevation (Photos D6 through D8).

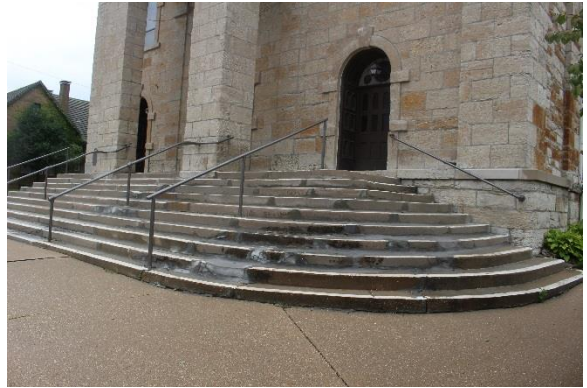
Photo F1

The stairs and landing at the south entrance consisted of concrete treads and risers and exhibited patch repairs throughout (Photos F1 and F2).

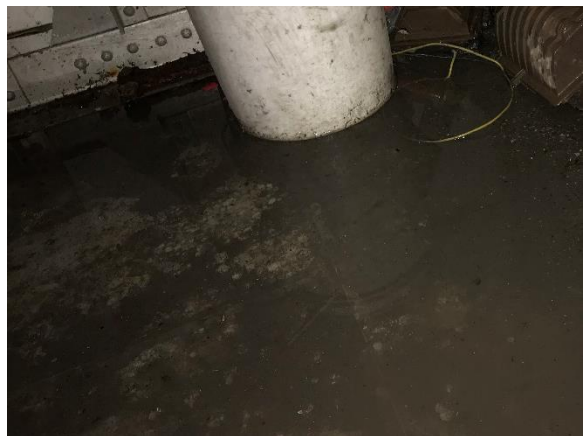
Photo H4

The steeple framing was in overall good condition. Breaches were located within the steeple roofing and cladding as evidenced by the standing water located on the steeple walking surface (Photo H4).

Overall, the steeple framing was in good condition with no corrosion observed. We recommend ensuring the roofing system is water tight, as discussed in Section A above, and periodically inspecting the steeple space for active leaks. Refer to Section A above.

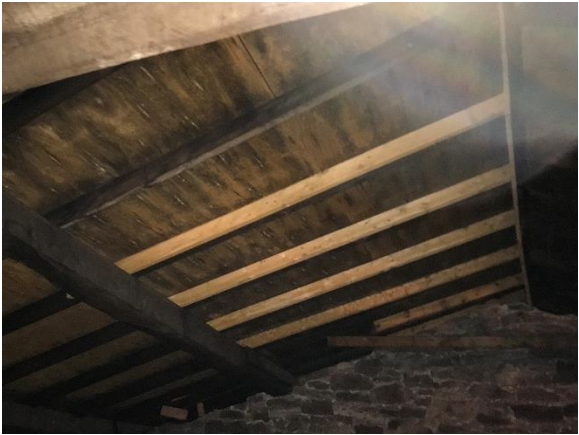
Photo I3

Prior roof framing repairs consisted of reinforcement of rafters (Photo I3), purlins (Photos I4 through I6), and truss reinforcement with steel plates, angles, and threaded rods within the original roof area (Photos I7 and I8).

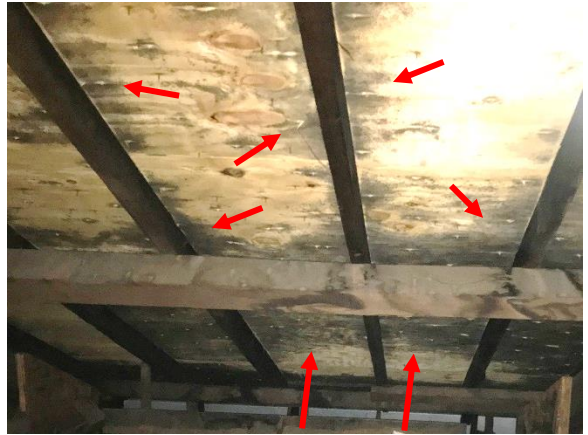
Photo I10

1. Evidence of moisture intrusion were observed throughout the attic.
  - a) Water stains were observed throughout the roof framing (Photo I10).
  - b) Microbial growth was observed typically on the underside of roof sheathing, indicative of inadequate ventilation of the attic (Photo I11).

The water stained wood framing appeared to be in serviceable condition with no structural deficiencies noted at the affected members. We recommend ensuring the roofing system is water tight, as discussed in Section B above, and periodically inspecting the attic space for active leaks. The displaced decking identified in Observation 1d above is expected to be remedied during replacement of the roofing over the main congregation area.

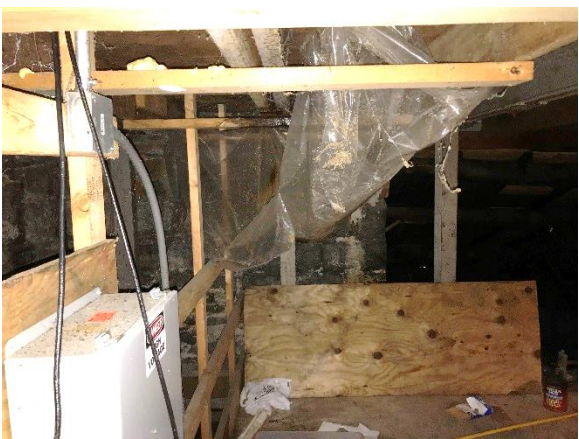
Photo I13

- d) At the south end of the roof, adjacent to the steeple framing, a water capture and drainage system consisting of plastic sheeting and buckets was observed (Photo I13). Steel steeple framing in the vicinity was wet and corroded (Photo I14). Wood framing and sheathing in the area was saturated and exhibited microbial growth (Photo I15).

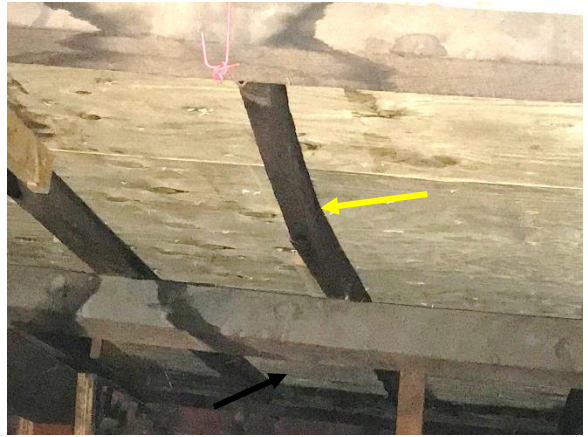
Photo I16

2. At the west-facing roof slope, a rafter was fractured (Photo I16).
3. At a 4x4 horizontal truss brace within the southern third of the original roof area, splintered wood fibers were observed at a toenailed brace connection (Photo I17). On the opposite face of the affected truss, the opposing horizontal brace was failed at the truss connection (Photo I18).

While the roof framing was in overall fair condition for its age, the fractured rafter, and two horizontal bracing members represent structural deficiencies that are recommended for remediation within the next year. In our opinion, one or more of these conditions is contributing to the ridge deflection as observed from the exterior (refer to Section B).

- At the fractured rafter, we recommend reinforcing with the sistered lumber of like size and species (or better).

I1	<b>Category 1</b> – Reinforce Fractured Rafter at West-facing Slope	\$800
I2	<b>Category 1</b> – Replace Fractured Horizontal Brace at South End	\$800
I3	<b>Category 1</b> – Reinforce Horizontal Brace Connection at South End with Cold-Formed Metal Joist Hanger	\$200

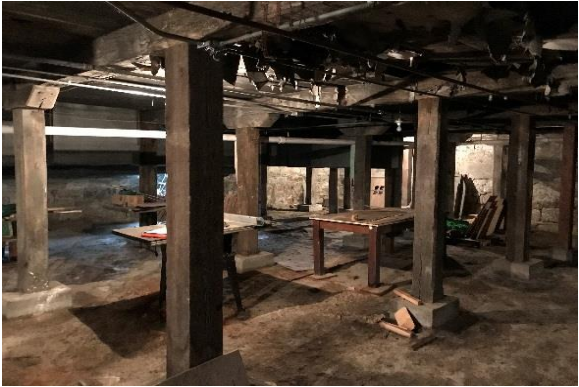
Photo J1

The basement beneath the main congregation area was accessed from a hallway beneath the east addition, with the entrance at the north end (Photo J1). Except where noted, main level framing was comprised of rough sawn framing; 2 ½" x 11 ½" decking spanned north-south and supported by rows of timber beams and columns at approximately 8'-0" centers (Photos J1 and J2). Beam sizes varied but most measured 6"x11¾"; beams spanned east-west and were supported by 7½"x7½" posts at 8'-0" on center. Posts were supported by cast in place concrete footings. The perimeter foundation walls were comprised of limestone or granite masonry (Photo J3).
