## STRUCTURAL CONDITION ASSESSMENT REPORT

### **St. Hyacinth Catholic Church**

American Structurepoint Project No. 2018.01714

February 13, 2019

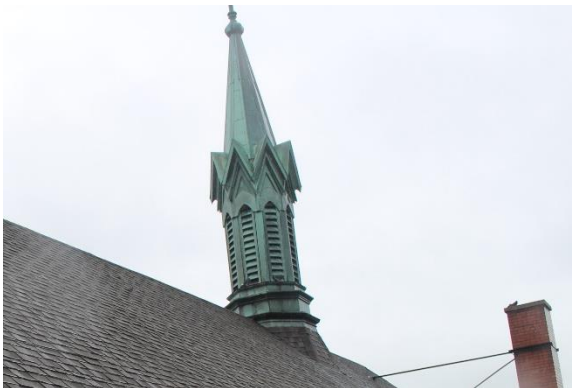
Photo BD11

Notable roof appurtenances included a formed copper steeple above the altar and a brick chimney (Photos BD11 and BD12).

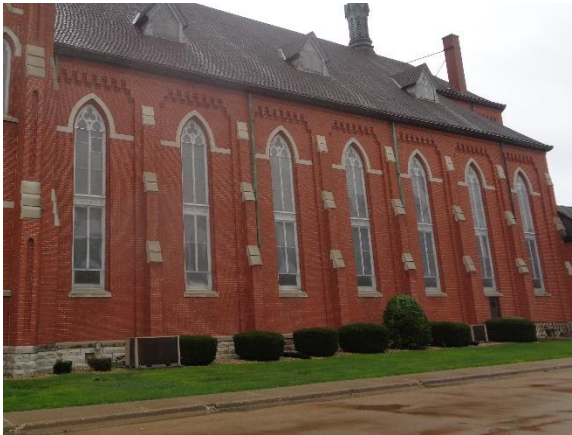
Photo D1

The exterior walls of the main congregation and sacristy areas are comprised of multiple-wythe clay brick masonry (Photos D1 through D3). Decorative masonry elements included cast stone window sills, window arches, louver sills, and the water table belt course (Photo D4); brick dentilwork was observed above windows and along the south elevation (Photos D2 and D3). Brick pilasters are located along the east and west elevations, evenly spaced between windows (Photos D1 and D2). Over their height, the pilasters have stepped projections of one, three, and five wythes from the majority of the elevation. All exterior brick appeared to be original to the structure.

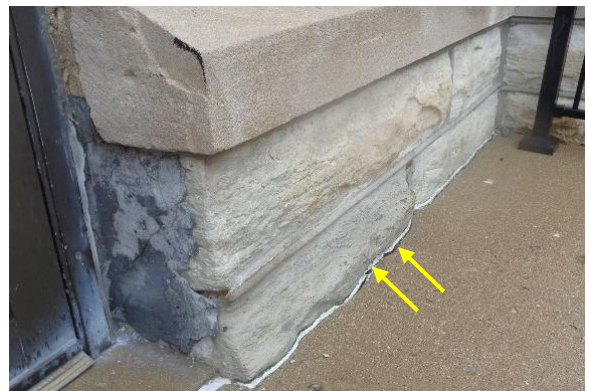
Photo D4

6. At the grade level limestone courses on the south and east elevations, failed sealant was observed at the cove joint along the sidewalk (Photo D4).
7. At the north elevation, a separation of approximately one inch was observed at the joint between the east wall of the basement entrance and the north sacristy wall (Photo D12).

Within the next two years, we recommend repointing the open mortar joints below windows, at pilasters, below copper gutters and missing downspouts, and at open cast stone joints. At the grade level limestone, we recommend sealant repairs along failed cove joints abutting the sidewalk. The suspended fragment of cast stone above the west elevation entrance should be removed.

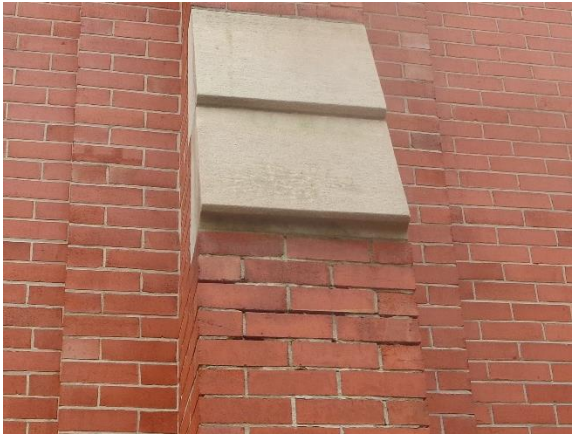
Photo D7

1. On the south elevation, open mortar joints were observed below a downspout which discharged approximately 10 feet above grade (Photo D5).
2. Select areas of open mortar joints were observed below some windows and at some pilasters (Photos D6 and D7).

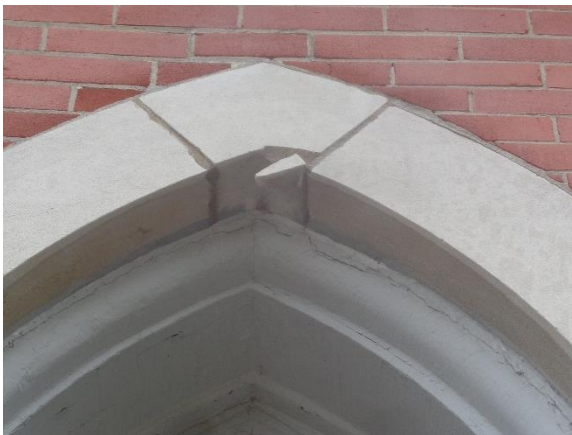
Photo D9

3. Throughout the building, select areas of open mortar joints were observed below the copper gutters (Photo D8).
4. At the west elevation, a small piece of cast stone was fractured, and suspended above the side entrance stoop (Photo D9).

D1	<b>Category 2</b> – Exterior Masonry Repairs	\$5,000
D2	<b>Category 1</b> – Remove suspended cast stone fragment at west entrance	Maintenance Staff

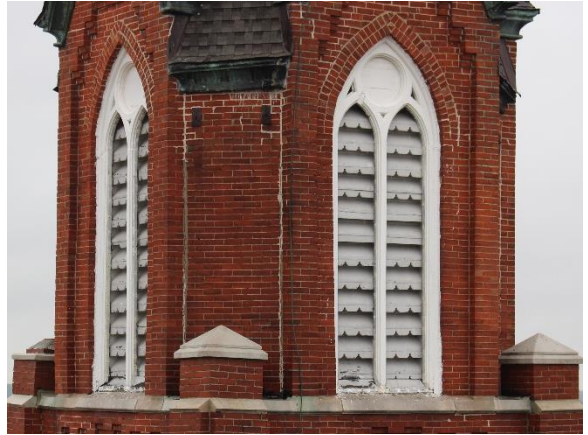
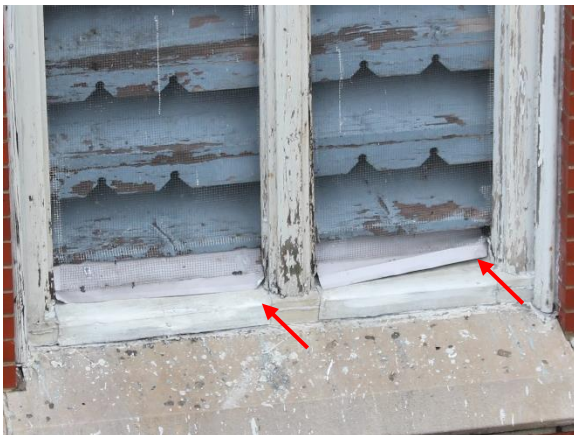
Ventilation louvers were located in the steeple belfry openings and accented with decorative wood panels and trim-work. Portions of the west steeple trim have been replaced or covered with sheet metal flashing (Photos E6 and E7).

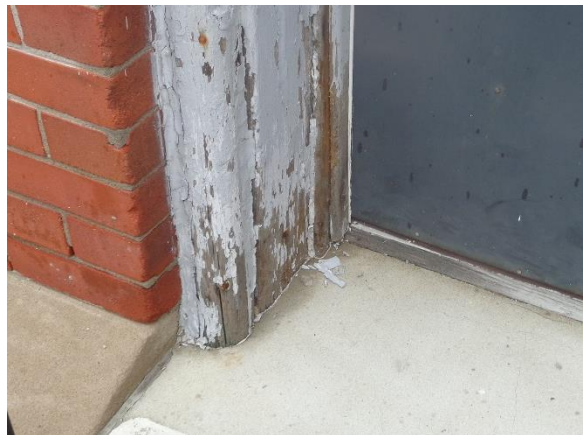
Photo E8

1. Typical at the doors, wood door jambs exhibited missing paint and exposed wood trim along the bottom edges (Photo E8).
2. Cracked acrylic storm panels were observed at windows on the north elevation (Photos E9 and E10).

E1	<b>Category 2</b> – Repaint Door Jambs & Decorative Wood Panels	\$5,000
E2	<b>Category 2</b> – Repaint Louver Trim & Decorative Paneling (Qty: 6)	\$9,000
E3	<b>Category 2</b> – Replace Cracked Storm Panels & Reseal Remaining Window Storms	\$15,000
E4	<b>Category 2</b> – Repaint South Elevation Window Trim	\$3,000
E5	<b>Category 2</b> – Replace Louver Counterflashing	\$2,000

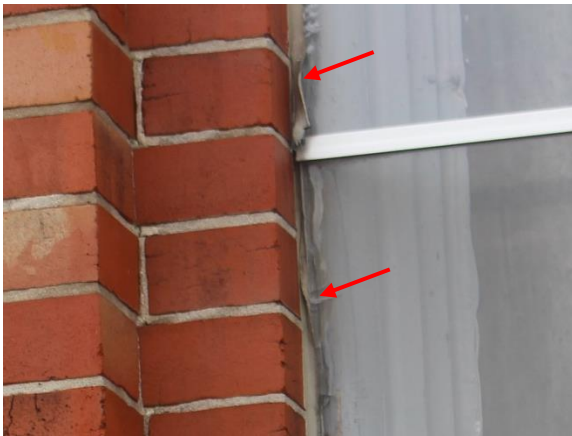
Photo E11

3. Storm panel sealant was in fair to poor condition overall with failed sealant observed at select storm panels throughout the building (Photos E11).
4. At the south elevation main window, the paint at the wood trim was cracked and flaking and the underlying wood exposed (Photo E12).

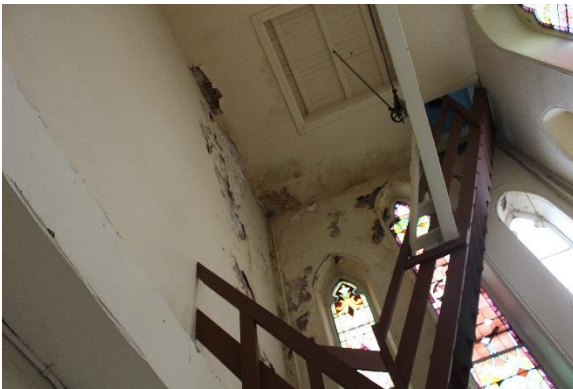
Photo H1

The steeple walls were finished with plaster between the main floor and the choir loft ceiling (Photo H1). A set of wood stairs provided access to each end of the choir loft, or steeple middle level (Photos H1 through H3, also ref. Photo C1 and C2). Above the middle steeple level, the walls of the upper, clock chamber, and belfry levels were unfinished, with the original clay brick masonry exposed (Photo H4). Cementitious skim coating was observed at the interior face of the brick beginning at the clock chamber levels (Photos H5 and H6). Timber framing members support the original bell platform and the steeple spire, and are embedded into the masonry walls at the upper steeple level (Photo H7 and H8).

2. Flaking paint and damaged plaster were observed throughout the middle level of both steeples. Plaster cracks were observed at window and wall corners (Photos H1, H11 and H12).

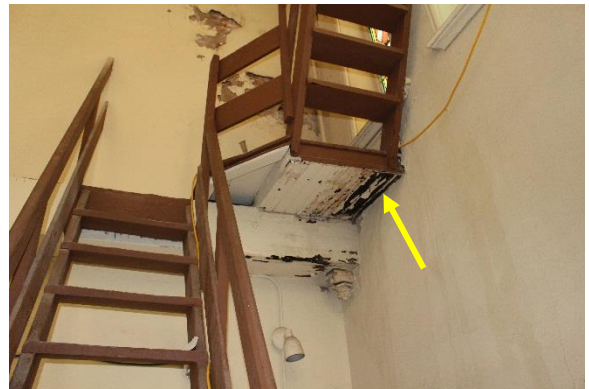
Photo H2

1. The wood steeple stairs were in overall fair condition, however, at the east steeple questionable support conditions were observed at the intermediate, middle level landing (Photo H2). The landing appeared to be supported by the timber beam at the north, and the masonry wall at the east side; however, the wood at the east side of the landing exhibited flaking paint indicative of moisture exposure and possible reduced structural capacity.

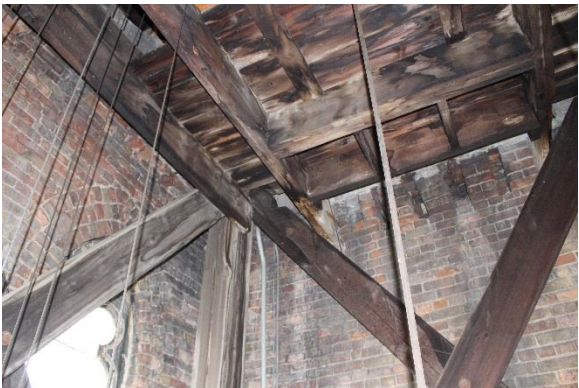
Photo H13

3. Timber framing at both steeples exhibited varying amounts of water staining typically throughout (Photos H13 through H16). At the southeast corner of the east steeple, a large timber exhibited rot and crushed wood fibers adjacent to the masonry bearing pocket (Photo H16).

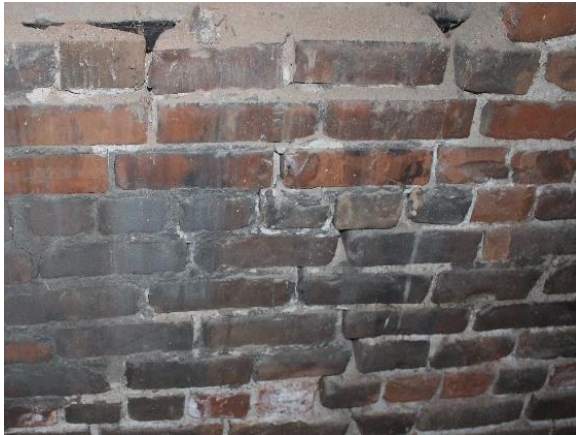
Photo H17

4. Steeple brickwork was generally in poor condition with rounded brick edges and eroded mortar joints typical throughout (Photos H17 through H24).
  - a. At the clock chamber, cracked and displaced brickwork was observed above and below the clock faces (Photos H18 through H20).

The observed masonry deterioration is consistent with moisture intrusion occurring over many years, and is attributed to breaches in the spire roofing and deterioration of the steeple mortar joints. At the west steeple, we recommend repointing the interior face of the exposed masonry within the upper level. Within the clock chamber, loose and damaged portions of cementitious coating should be removed. Cracks in the cementitious coating should be reinforced with helical mortar joint reinforcement installed into the underlying horizontal brick joints, followed by patching of the cementitious coating.

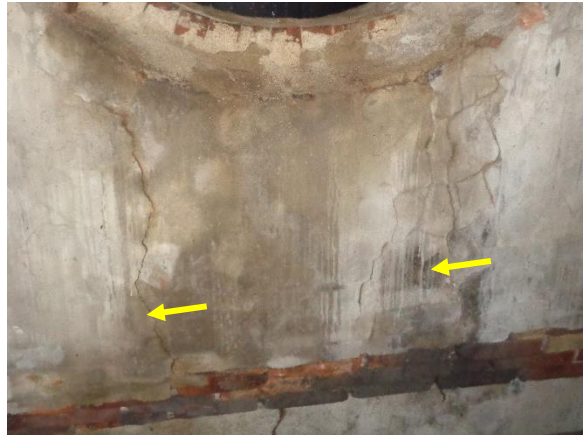
Photo H18

- b. At the east steeple clock chamber, the cementitious coating exhibited fractures throughout; above and below the clock faces cementitious coating, along with brick, was fractured and displaced out of plane (Photos H18 through H20). Brick courses immediately beneath the lowest extent of cementitious coating were severely eroded (Photo H21).

At the east steeple, as discussed in Section D above, we recommend reconstructing the clock chamber and belfry levels. We recommend repointing the exposed brick within the upper level of the east steeple.

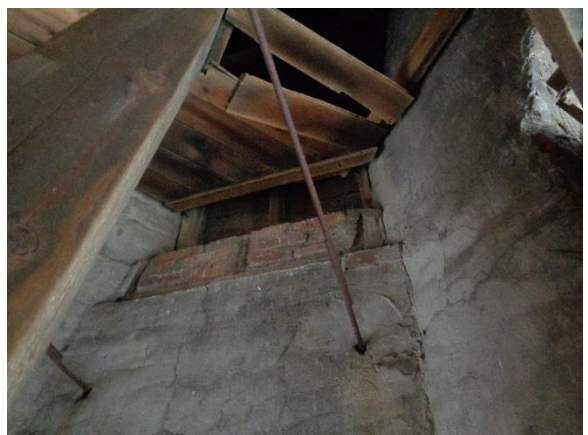
Photo H22

- c. At the east steeple belfry, the cementitious coating exhibited significant cracking and out-of-plane displacement of the brickwork (Photos H22 through H24).

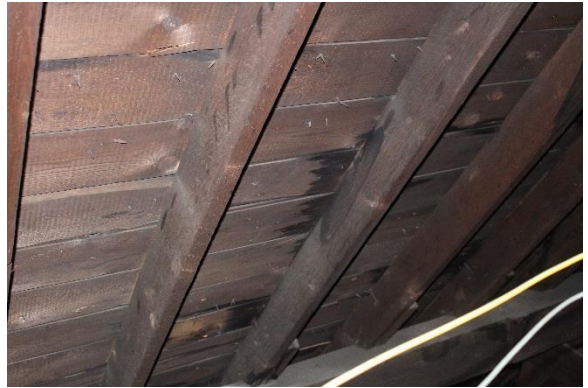
Photo I4

1. Water stains were observed throughout many of the rafters (Photo I4).
2. Saturated wood and water stains were observed at the framing and decking supporting and surrounding the copper ventilation steeple at the north end (Photo I5).

The water stained wood framing appeared to be in serviceable condition with no structural deficiencies noted at the affected members. We recommend ensuring the roofing system and copper ventilation steeple is water tight, as discussed in Section B above, and periodically inspecting the attic space for active leaks. The fractured decking identified in Observations 3 and 4 above is expected to be remedied during replacement of the roofing over the main congregation area. Refer to Section B above.

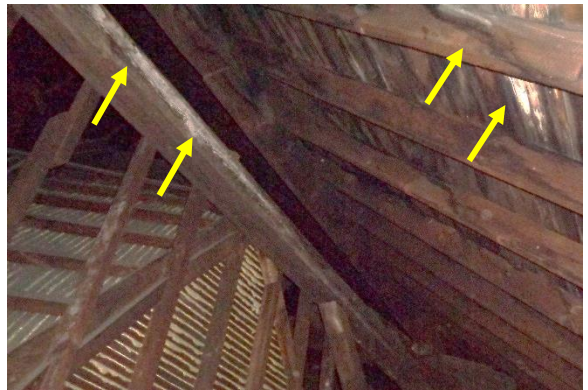
Photo I6

3. At the southernmost 12 feet of the east-facing roof slope, water stains and areas of microbial growth were observed at the underside of the roof framing (Photos I6 and I7). Along the south masonry wall, an area of missing decking was observed (Photo I7).

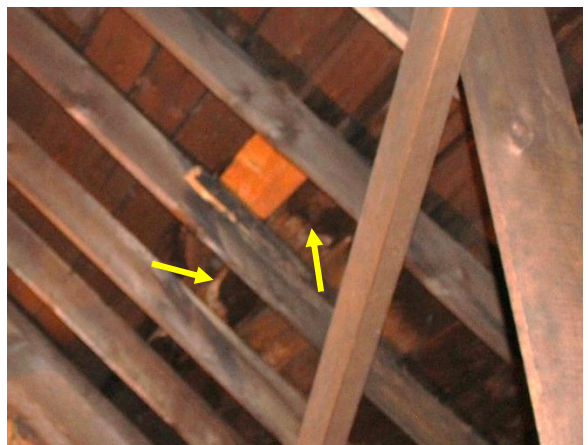
Photo I8

4. At the west-facing roof slope, an area of fractured decking was observed (Photo I8).
5. From our vantage point on the central catwalk, wood lath and plaster keys were in generally fair condition with some evidence of age and vibration-related deterioration of the keys as evidenced by bright, granulated plaster (Photo 9). No fractured lath was observed from our vantage point. No handrail was located on the central catwalk.

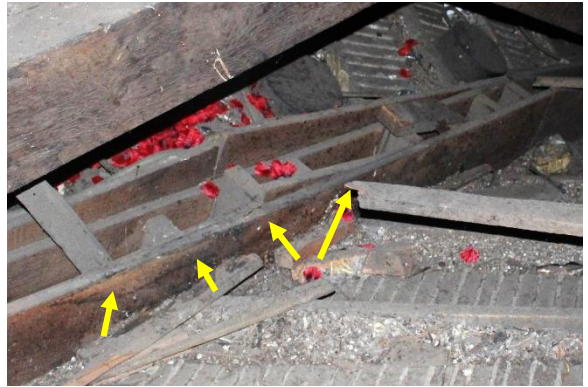
Photo I10

6. Above the altar, a fractured brace was observed adjacent to the ceiling arch framing (Photo 10). Water staining was observed on the arch framing at the location the fractured brace appeared to have been originally fastened. Bird and/or bat excrement was observed atop the plaster framing in this area.

The fractured ceiling brace should be replaced at the time of plaster repairs.

I1	Category 1 – Replace fractured ceiling brace near altar arch	\$800
----	--	-------
